# Structural Survey Report

“Ocean Way”  
10 North Shore Rd  
Smiths

Mason and Associates Ltd  
March 15th, 2012

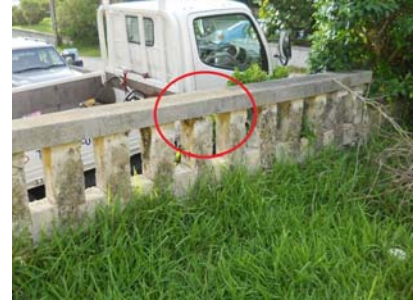
The remaining decorative parapet wall was noted to be loose with significant cracking. This wall bounds the east neighboring property. Ownership to be determined.

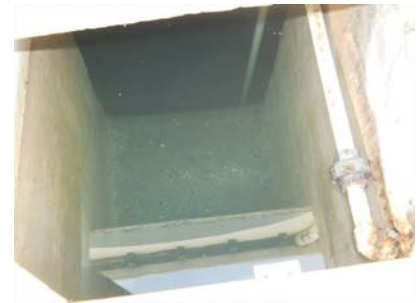
Tank is full and could not be accessed for a thorough inspection. Some silt deposited on access ledge infers that the tank may need a cleaning. Tank access covers should be replaced with a galvanised lid/frame with locking bar.

Tank is full and could not be accessed for a thorough inspection. Some silt deposited on the access ledge infers that the tank may need a cleaning. Tank access covers should be replaced with a galvanised lid/frame with locking bar.

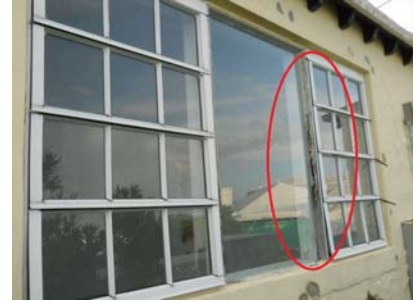
Several areas noted where aluminum framing to masonry boundary requires caulking. West picture window frame shows signs of wood rot and should be replaced with new.

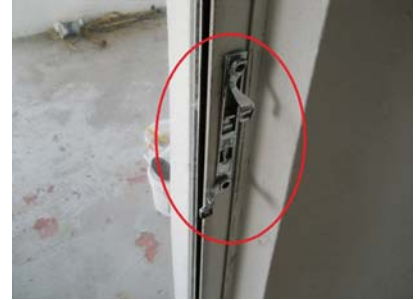
South entry door is aluminum and satisfactory. North access door is 6ft sliding glass type and

requires maintenance. Locking mechanism could not be operated.

South entry door is aluminum and satisfactory. North access door is 6ft sliding glass type and requires maintenance. Locking mechanism appears broken and we could not be operated.

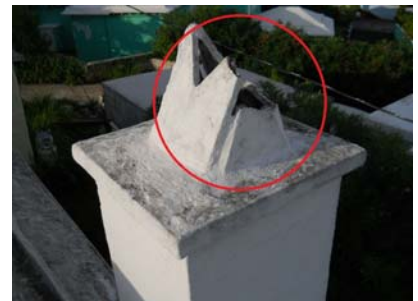
Exterior masonry cracking noted, typical of local construction. Repair with elastomeric caulking compound to seal, prime and paint. Top cap is damaged and requires replacement with mesh screen.

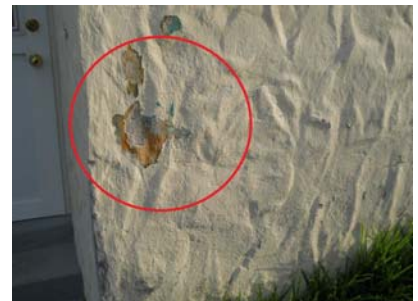
Exterior wall surface shows some minor hairline cracking typical of local construction. Loose plaster and hollow areas should be hacked off to sound masonry, sealed and painted. Hairline cracks should be v-notched and sealed with a quality elastomeric caulking, primed and painted.

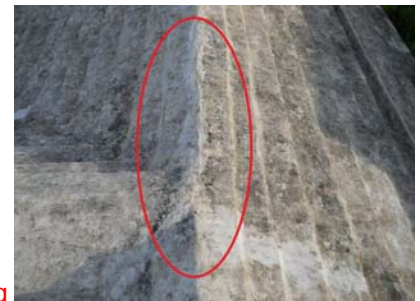
Roof exhibits significant discoloration from deferred maintenance. Several recently repaired cracks are satisfactory. Several un-repaired cracks and spalling noted. Repair, clean and recoat at earliest opportunity.

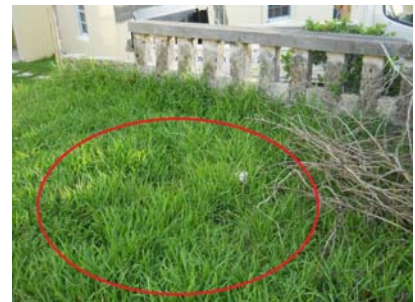
A depression in the ground around the cesspit was noted. This should be investigated further.

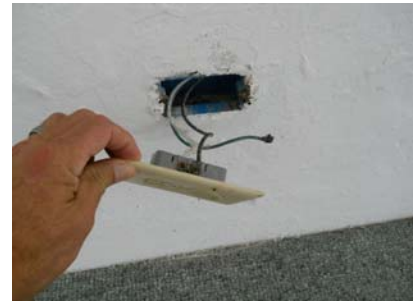
Outlets and switches appear satisfactory in general. One outlet in the dining room is loosely attached and requires the ground wire to be reattached. One switch cover plate noted as missing in bedroom. These are minor defects easily fixed.

Outlets and switches appear satisfactory in general. **One outlet in the dining room is loosely attached and requires the ground wire to be reattached. One switch cover plate noted as missing in bedroom. These are minor defects easily fixed.**

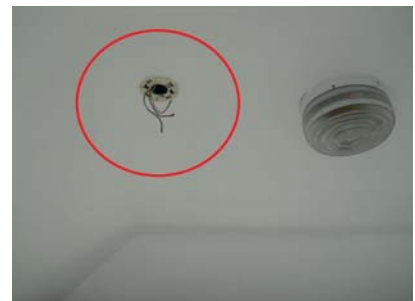
Wiring and brackets are in place but smoke detectors have been removed from several rooms. Reinstall with new and test.

**Wiring and brackets are in place but smoke detectors have been removed from several rooms. Reinstall with new and test.**

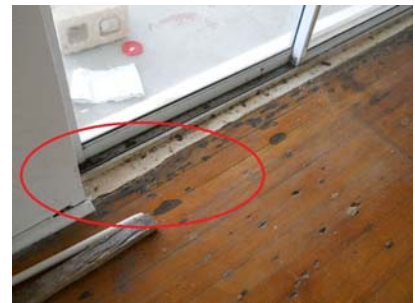
Vinyl in kitchen shows discoloration and tears. Replace with new. Carpet in dining room and bedrooms is satisfactory with only minor wear and discoloration noted. Wood floors appear sound and free from significant damaged from wood boring insects. Some discoloration, scuffing and staining noted in the living room. Floor would benefit from sanding and refinishing.

Vinyl in kitchen shows discoloration and tears. Replace with new. Carpet in dining room and bedrooms is satisfactory with only minor wear and discoloration noted. Wood floors appear sound and free from significant damaged from wood boring insects. Some discoloration, scuffing and staining noted in the living room. Floor would benefit from sanding and refinishing. Some pitting and water damage/rot noted at sliding door.

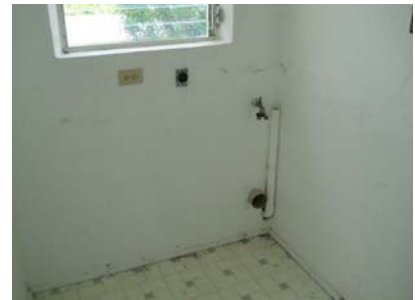
Some minor efflorescence and hairline plaster cracks noted as typical for Bda construction.

Roof and exterior walls should be repaired and sealed before addressing interior walls.

Some minor efflorescence and hairline plaster cracks noted as typical for Bda construction. Roof and exterior walls should be repaired and sealed before addressing interior walls.

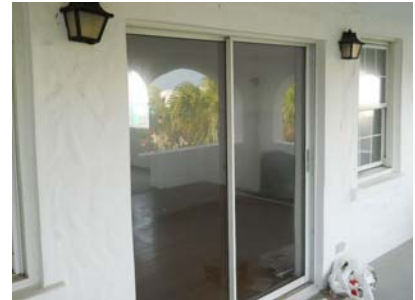
Sliding door could not be unlocked. As such its functionality could not be fully tested. Door handle/lock needs replacing with new, both sides.

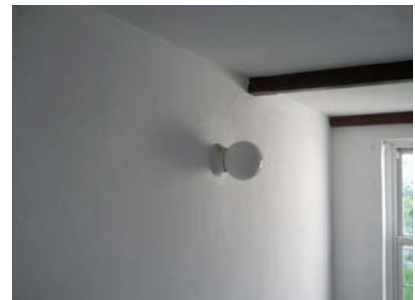
Minor areas of discoloration and paint flaking due to moisture noted.

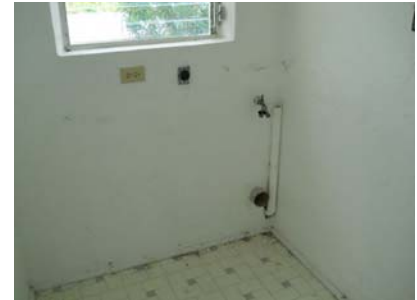
Some mildew discoloration noted.

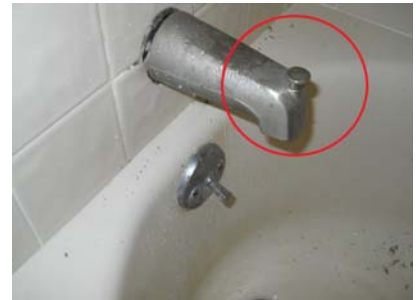
No obvious defects noted. Shower head and faucet show degradation and age and would benefit from replacement with new. Tub faucet plunger is inoperable. Replace with new.

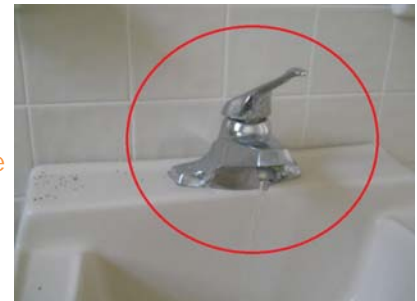
Functional with no signs of chips or discoloration. Faucet is pitted and should be replaced with new. Flow and pressure appear a bit weak.

Functional with no signs of chips or discoloration. Faucet is pitted and should be replaced with new. Flow and pressure appear weak.

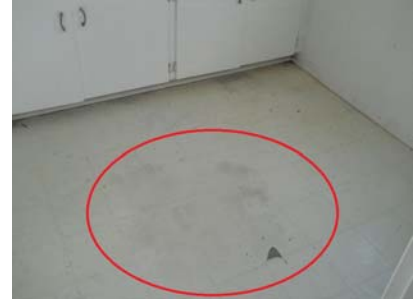
Tears and discoloration noted. Replace with new.

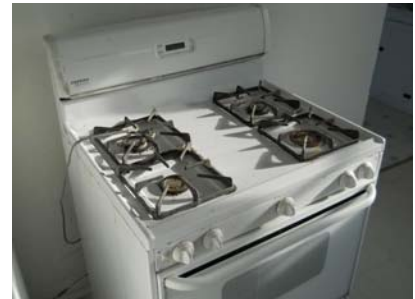
Stove appeared to be aged and shows signs of corrosion. Not tested.

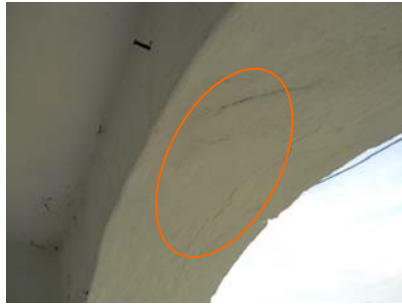
Efflorescence and flaking on north porch arches

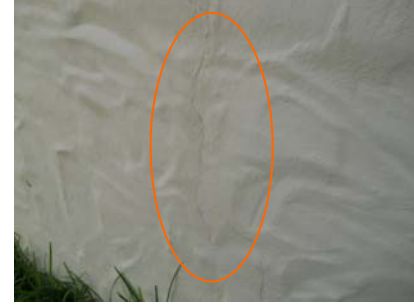
Hairline masonry cracks

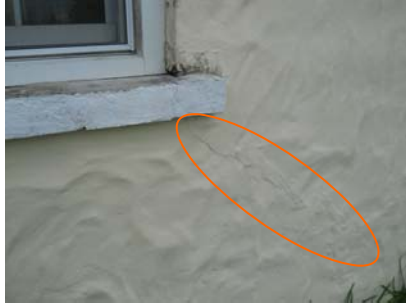
Hairline cracks, mildew and efflorescence

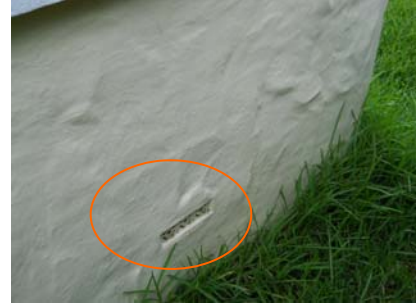
Masonry crack. Previous repair noted.

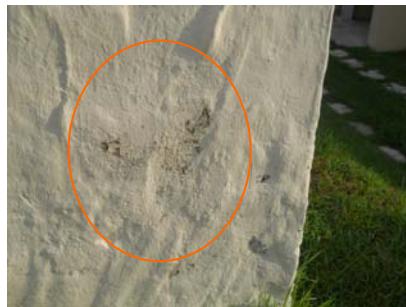
Masonry cracks.

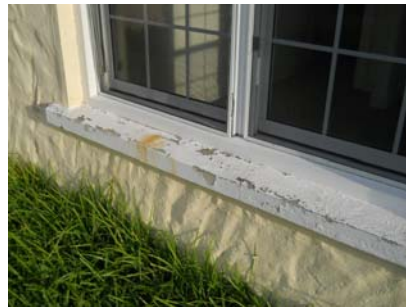
Caulking is missing

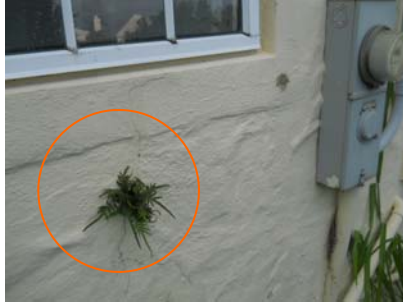
Mildew from excessive moisture in stone.

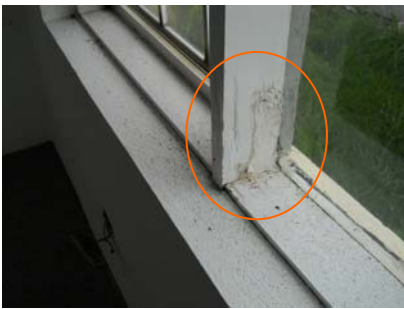
Windows with no visible caulking

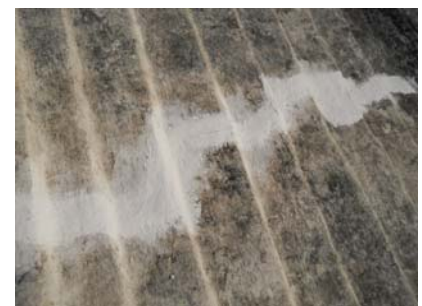
Significant cracking and spalling of plaster. Repair. ↑

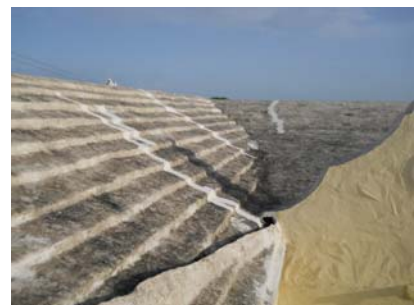
Roof cracking. Repair

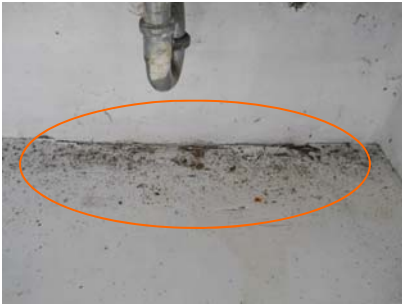
Efflorescence and degradation inside laundry room cabinets
