# Structural Survey Report

“Ocean Way”  
10 North Shore Rd  
Smiths

Mason and Associates Ltd  
March 15th, 2012

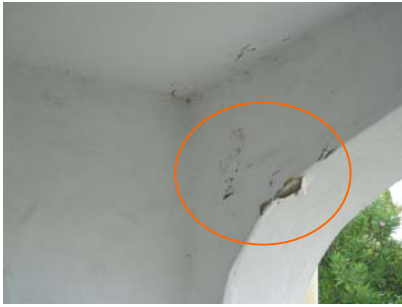
Efflorescence and flaking on north porch arches

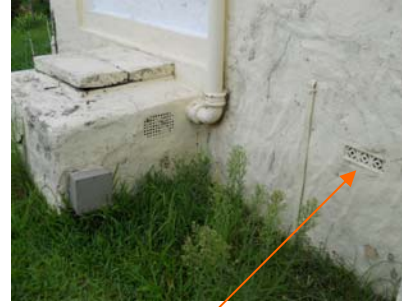
Tank is full and could not be accessed for a thorough inspection. Some silt deposited on the access ledge infers that the tank may need a cleaning. Tank access covers should be replaced with a galvanised lid/frame with locking bar.

Tank access. Floor vent

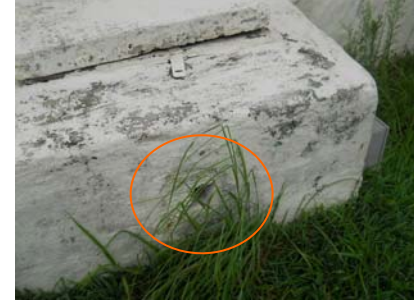
Tank overflow. Replace wire mesh screen

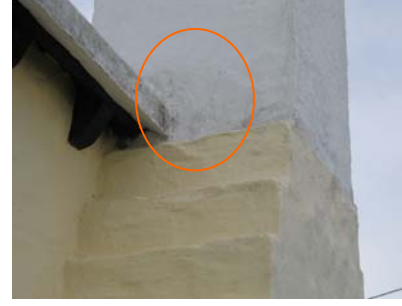
Exterior wall surface shows some minor hairline cracking typical of local construction. Loose plaster and hollow areas should be hacked off to sound masonry, sealed and painted. Hairline cracks should be v-notched and sealed with a quality elastomeric caulking, primed and painted.

Hairline masonry cracks

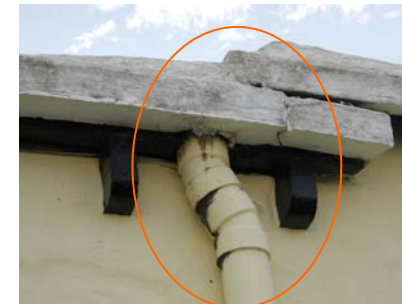
Mold indicates long term moisture issue with cracking and seal around downpipe

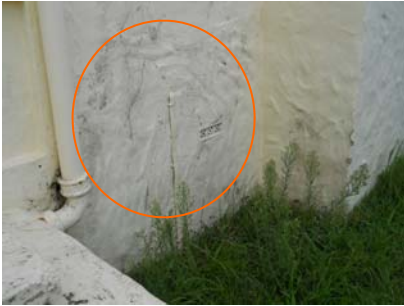
Hairline cracks, mildew and efflorescence

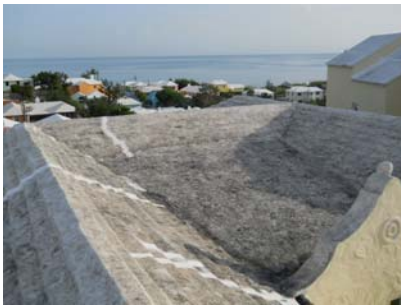
Previous repairs

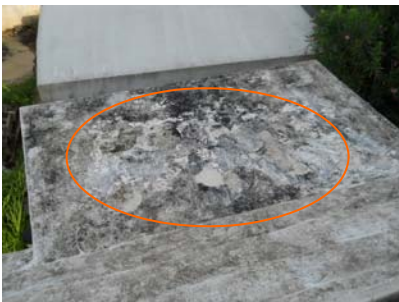
Recent repair is satisfactory

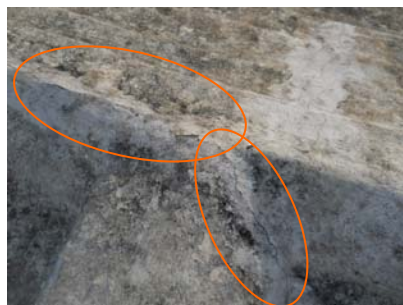
Significant spalling on flat roof, west side.

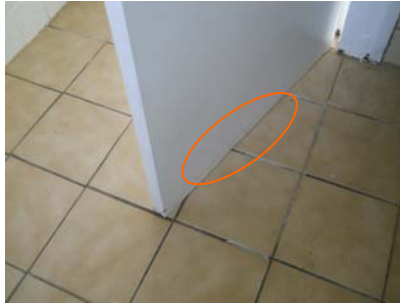
Kitchen base cabinet shows wood rot

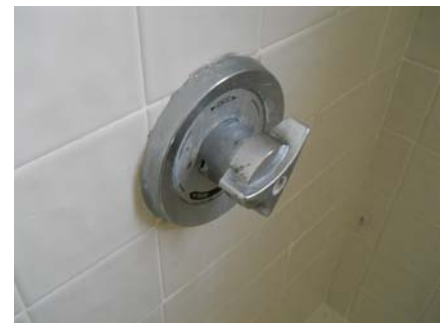
No obvious defects noted. Shower head and faucet show degradation and age and would benefit from replacement with new. Tub faucet plunger is inoperable. Replace with new.

Bathroom shower head looks aged.
