# Structural Survey Report

“Ocean Way”  
10 North Shore Rd  
Smiths

Mason and Associates Ltd  
March 15th, 2012

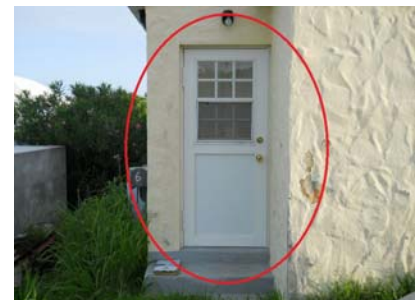
Entry steps on south side are satisfactory.

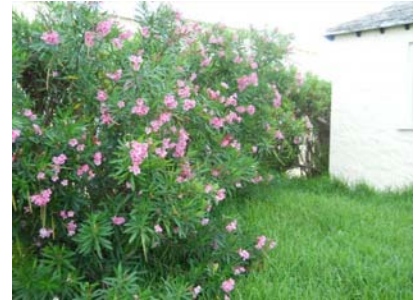
No trees or shrubs in close proximity to house.

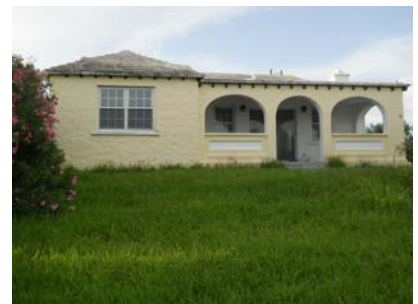
Property has good grading with no obvious signs of storm water runoff problems.

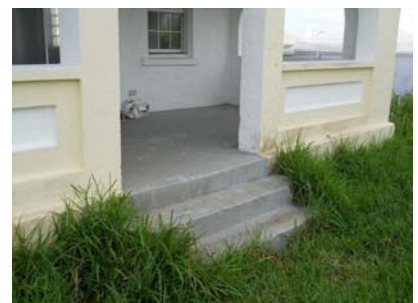
Covered porch facing north is satisfactory. No cracks or trip hazards noted. Slab appears to slope to drain.

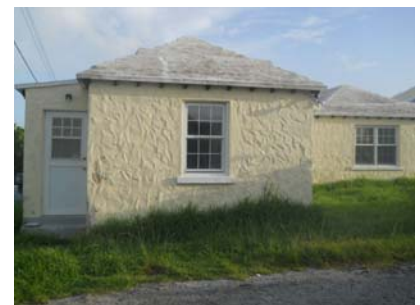
Building is typical masonry walls with Bda stone slate roof. Textured/patterned plaster walls on exterior.

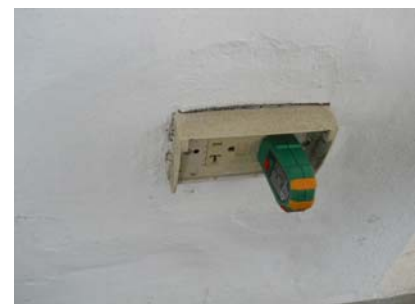
Located on north covered porch. GFCI tested OK.

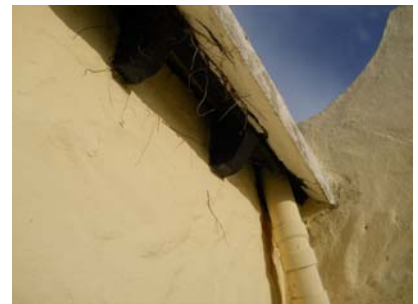
Exposed wood eaves appear satisfactory and consistent with age of the structure. Little to no damage from wood boring insects noted.

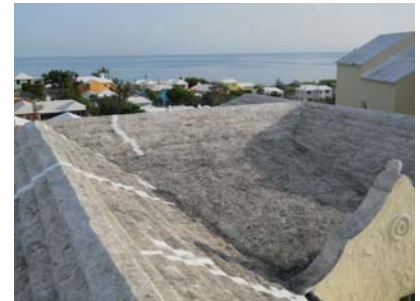
predominantly hipped roof construction with areas of flat roof.

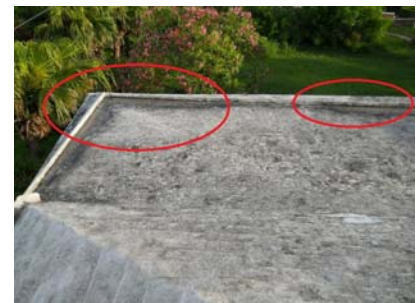
North flat roof gutters show ponding of rainwater. Re-slope gutters to drain adequately.

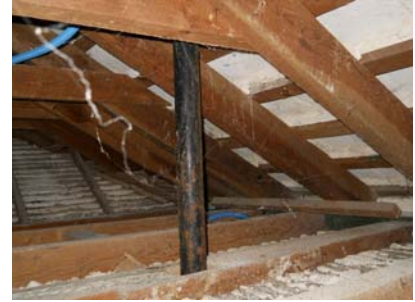
Roof framing members are dry and robust. No signs of damage from wood boring insects noted. Visual inspection limited to area around bathroom scuttle hatch.

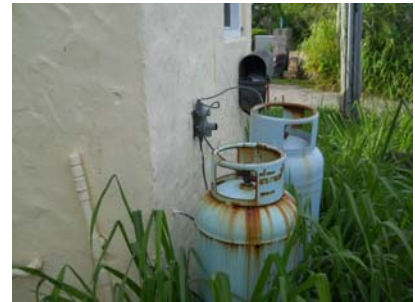
Gas cylinders located on west side appear satisfactory.

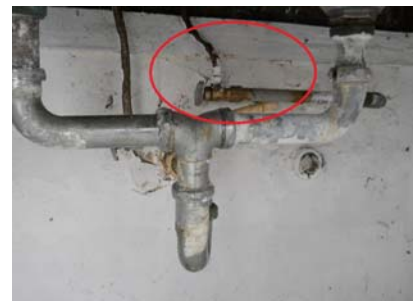
Shut off valves and supply lines appear aged and would benefit from replacing with new throughout.

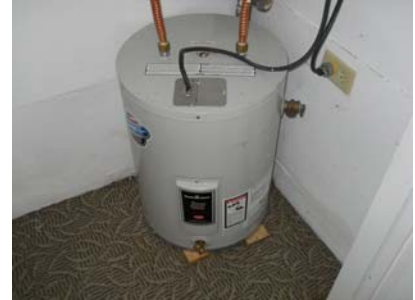
Water heater tested OK. Wired with on/off switch

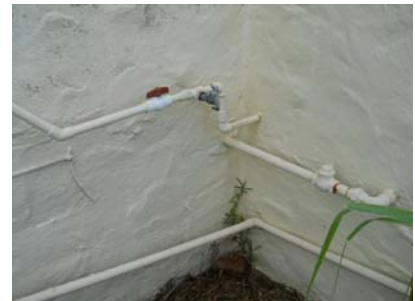
Interior supply lines appear to be PVC and connected to older galvanised in-ground iron piping.

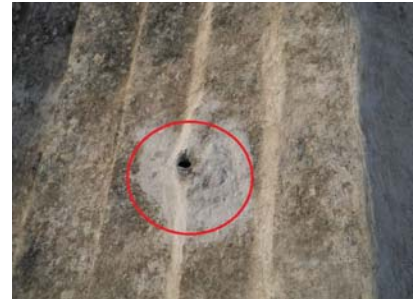
Hole at roof level may be a vent pipe. Investigate further. Block or extend as required.

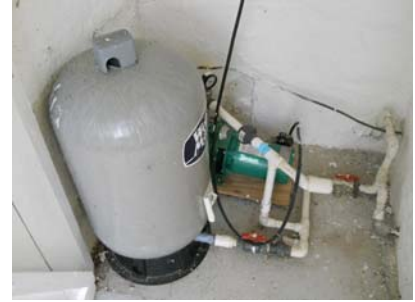
Pump appear relatively new and functional. Small pressure tank is functional. System tested OK.

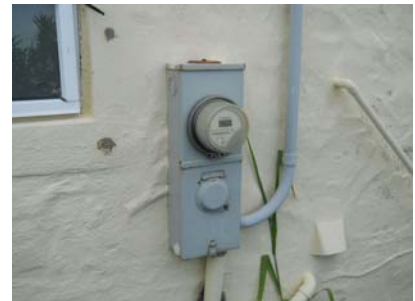
Underground Belco feed from southwest pole is satisfactory. Belco meter on west side of structure.

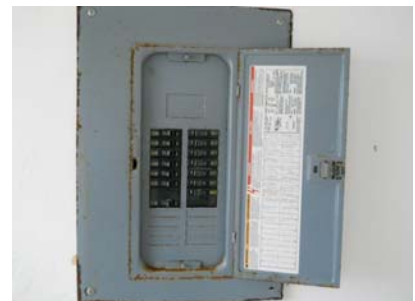
The panel cover could not be removed at screws. As such the panel wiring could not be inspected. Panel appears relatively new with only minor edge corrosion. The use of blue-flex conduit throughout the roof space would infer the wiring has recently been upgraded.

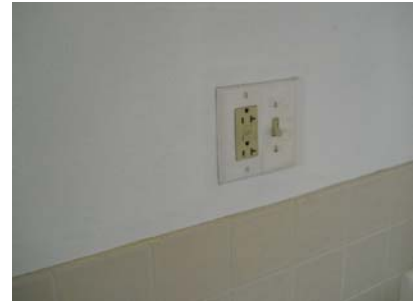
All GFCI outlets tested ok

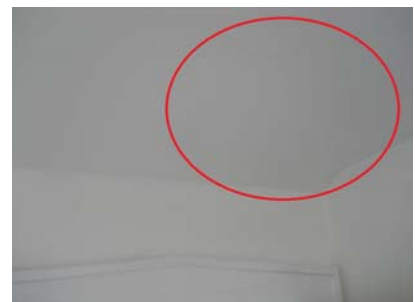
Ceilings in general appear sound and free from excessive damage and discoloration. Some minor hairline cracking in north bedroom noted. Monitor after roof is repaired and sealed.

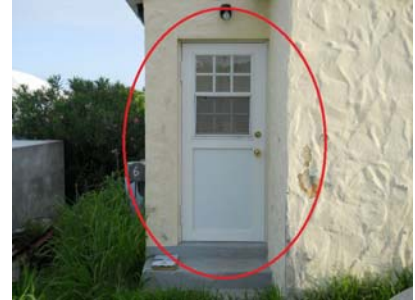
South metal door is satisfactory.

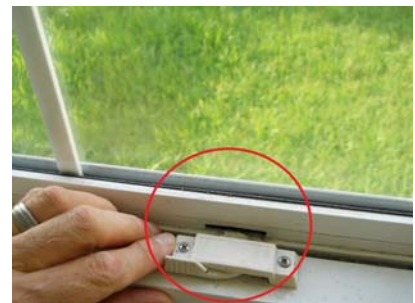
Sash windows are satisfactory in general. A representative sampling shows stiff but adequate functionality. Locking latch in south bedroom window was noted as defective. Adjust or replace with new.

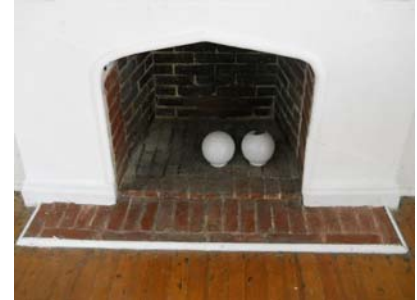
Fireplace was not tested but appears functional. It should be cleaned by a certified professional prior to operating

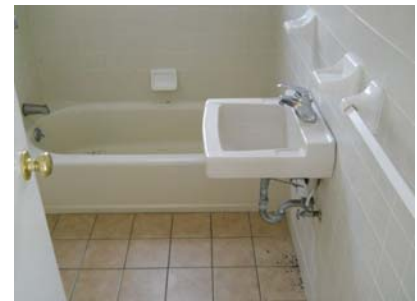
Bathroom appears functional and modern.

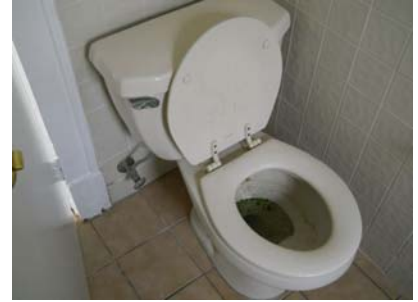
Toilet is stained but appears functional. Flush mechanism tested OK

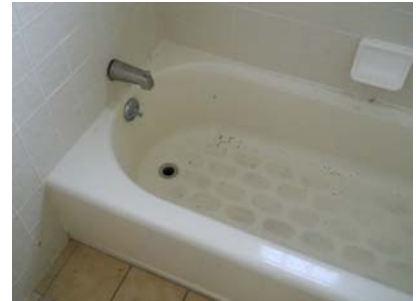
No signs of rust or chipping.

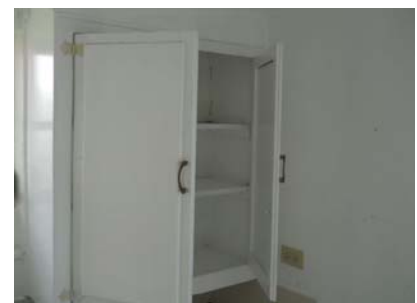
Solid wood cabinets appear functional.

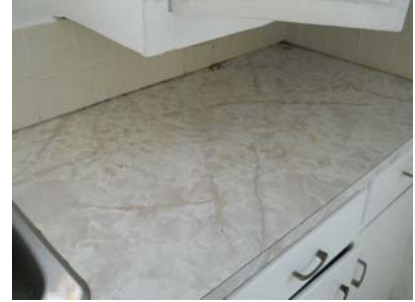
No signs of discoloration, scorching or stains.

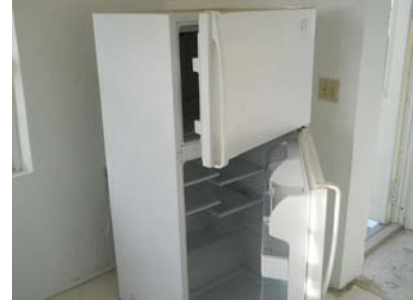
Unplugged and not tested but appears functional and satisfactory. **Check**

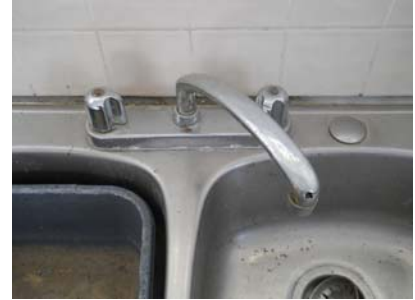
Sink appears functional. **Faucet appears aged and should be replaced with new.**

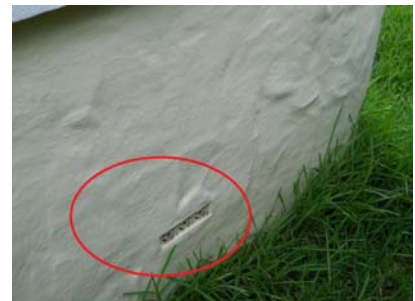
Sub floor space could not be accessed although several floor vent bricks noted,.

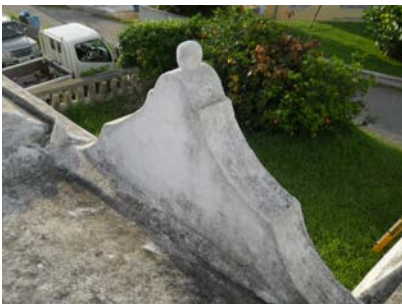
Masonry crack

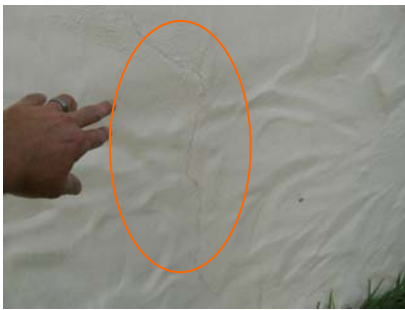
Masonry cracks.

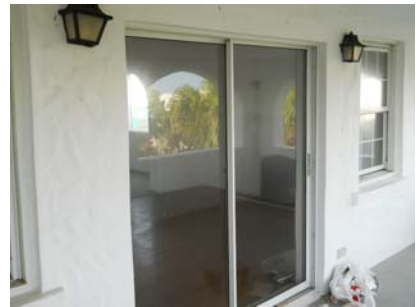
Efflorescence

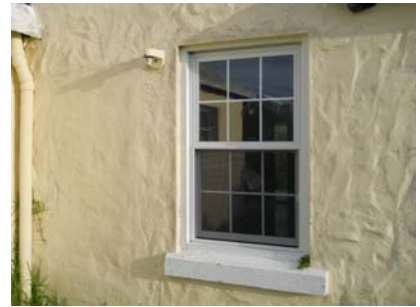
Flaking paint on window sill
